U.S. Department
of Transportation

Pipeline and Hazardous
Materials Safety
Administration

Reference No. 16-0147

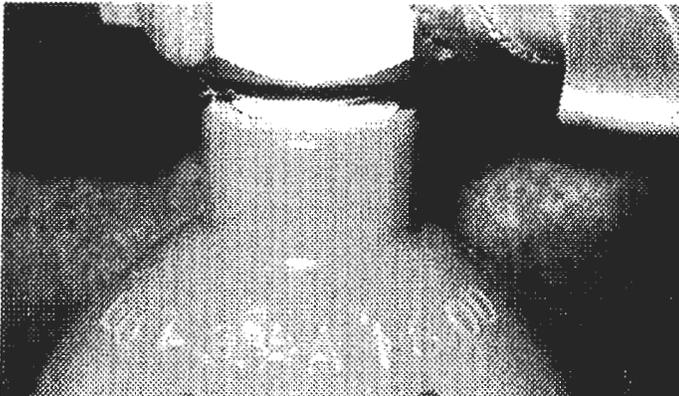
Qantas operates cylinders that are manufactured to the DOT 3AA specification (ref Figure1), they are used exclusively for oxygen, have a capacity of 11cu foot and manufactured by Avox Systems Inc. These cylinders are maintained under an approved System of Maintenance, to a vendor supplied, Component Maintenance Manual, CMM 35-31-55.

Cylinders conforming to these additional criteria are identified with a star shaped stamp. The 10year option has been chosen by Qantas.

Figure 1 - Typical oxygen cylinder with 3AA DOT marking
